# Manhole Inspection Summary

Manhole # S17G\_\_043MH

Insp Date: **10/5/07 1:38 PM**

**Location** Address: **12 GORMAN AVE**

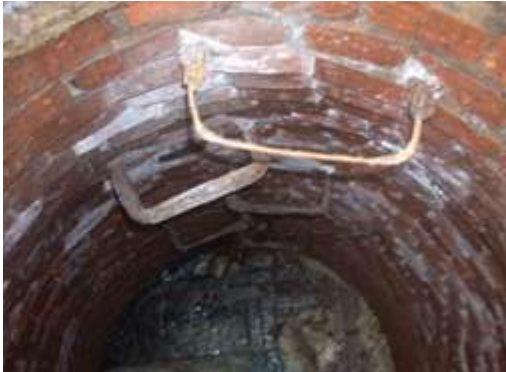
Defect 2

**Steps** Count: **5** Missing: **0** ☒ **Corroded**

CORRODED STEPS

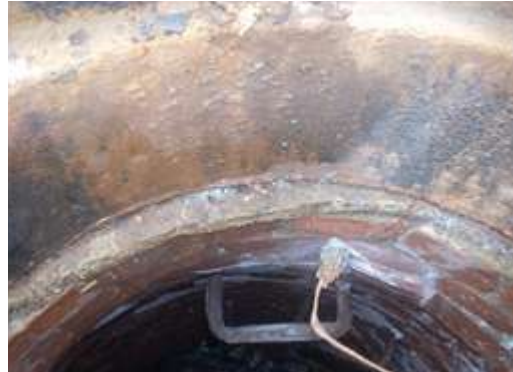
Defect 1

**Frame** Offset: **1** (in.) Condition: ☒ Sound ☐ Cracked ☐ Leaks

FRAME OFFSET

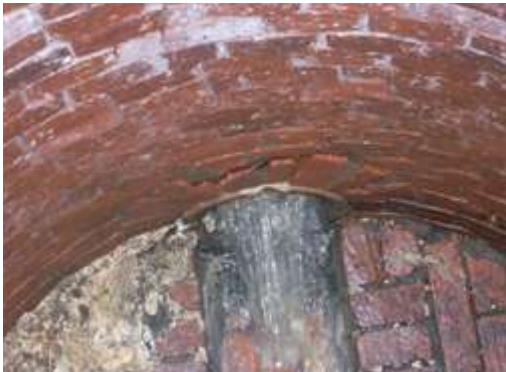
Defect 3

Condition: ☐ Sound ☐ Cracked ☐ Root Intrusion ☒ **Loose Brick** ☐ Deteriorated

LOOSE BARREL BRICKS

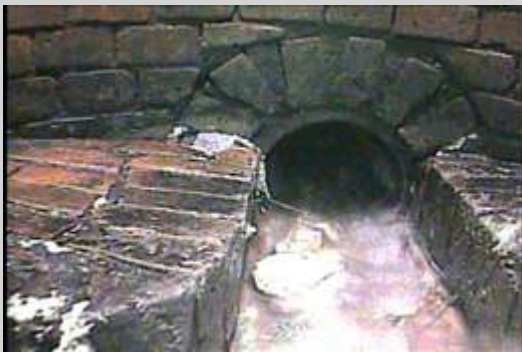
12 O'Clock Outflow

8 in. Circular Gravity Sewer  
Pipe Out @ 12 O'Clock

Pipe Height: **7.2** (in.) Rod and Bar (Angled)  
Pipe Material: **Clay** ☐ Pipe Lined  
Invert Depth: **8.57** (ft.) Flow Characteristics: **Fast**  
Deposits: ☒ None ☐ Mud ☐ Sludge ☐ Debris ☐ Grease  
Silt Depth: (in.) Deposits Extent:  
Infiltration: **None** Pipe Seal Cond: **Sound**

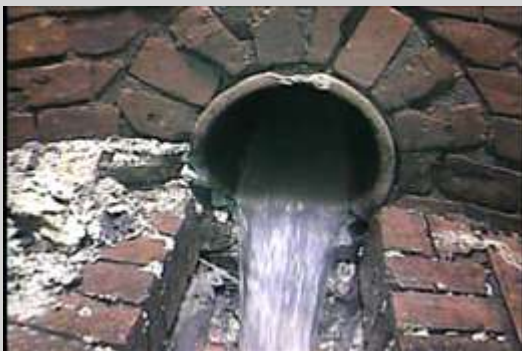
9 O'Clock Inflow

8 in. Circular Gravity Sewer  
Pipe In @ 9 O'Clock

Pipe Height: **8.4** (in.) Rod and Bar (Angled)  
Pipe Material: **Clay** ☐ Pipe Lined  
Invert Depth: **8.00** (ft.) Flow Characteristics: **Fast**  
Deposits: ☒ None ☐ Mud ☐ Sludge ☐ Debris ☐ Grease  
Silt Depth: (in.) Deposits Extent:  
Infiltration: **None** Pipe Seal Cond: **Broken**
